Manhole Inspection Summary

Manhole # S02WW1013MH

Location Address: **3902 W STRATHMORE AVE** Cross Street: **HOPETON AVE**

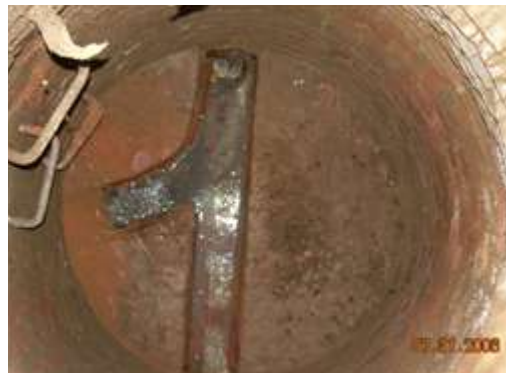
Top View

Corroded and missing steps. Evidence of surcharge - Bench debris. Channel debris.

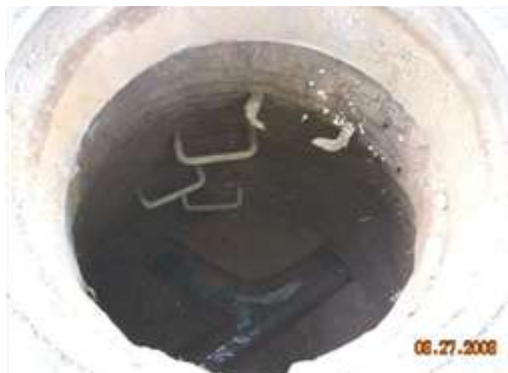
Defect

Adjustment deterioration and infiltration. Corbel and Barrel infiltration.

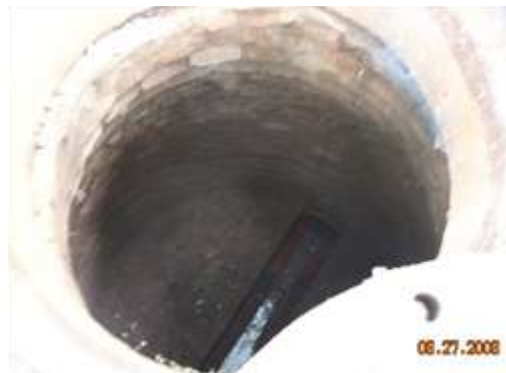
Defect

Adjustment deterioration and infiltration. Corbel and Barrel infiltration - other side.

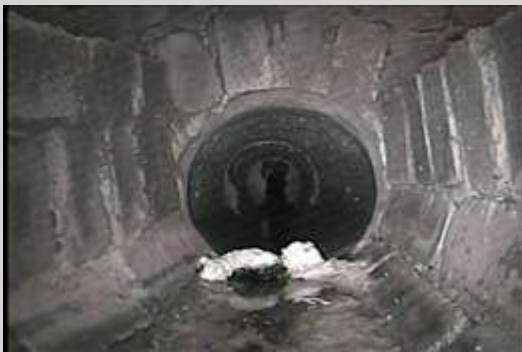
8 in. Circular Gravity Sewer Pipe Out @ 12 O'Clock

Barrel deterioration and infiltration. Channel deterioration.

Infiltration: **Evidence** Pipe Seal Cond: **Unknown**

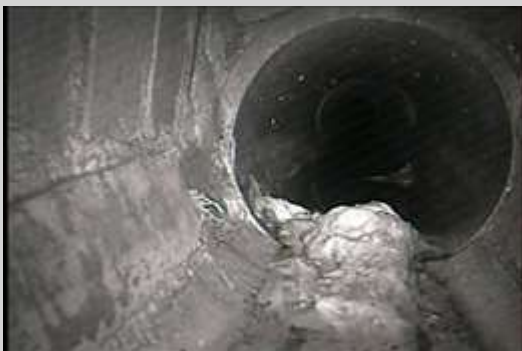
8 in. Circular Gravity Sewer Pipe In @ 6 O'Clock

Channel root intrusion.

Infiltration: **None** Pipe Seal Cond: **Cracked**

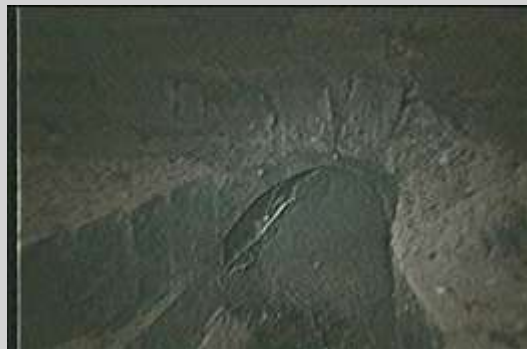
Pipe In @ 9 O'Clock

Barrel deterioration and infiltration. Channel deterioration and root intrusion.

Silt Depth: **8** (in.)

Deposits Extent: **Heavy**
